PROBLEMS OF LANDSCAPE ARCHITECTURE
IN
THE NATIONAL FORESTS

REPORT TO U. S. FORESTER'S OFFICE
ON
TRIP OF INSPECTION THROUGH SOME OF THE NATIONAL FOREST AREAS
IN
REGIONS 2, 4, 6 AND 1

BY
A. D. TAYLOR
CONSULTING LANDSCAPE ARCHITECT
SEPTEMBER 1935

(July 26, 1935 through August 22, 1935)

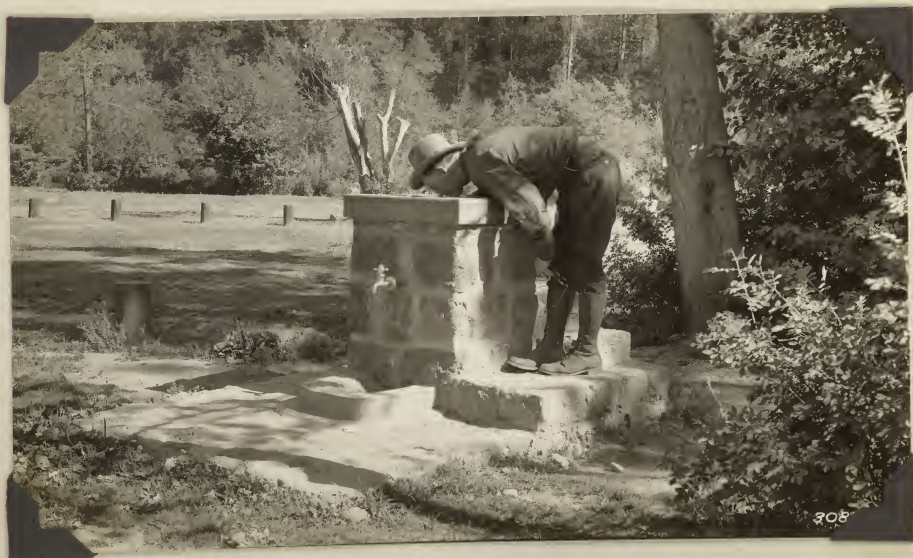
Targhee National Forest - Warm River Forest Camp

Detail view of a typical drinking fountain used in this camp ground area. This type of fountain might be well adapted to a forest camp ground if careful study were devoted to some of the details in order to produce a more definite informal texture in the stone work and a less artificial detail for the top of the fountain.

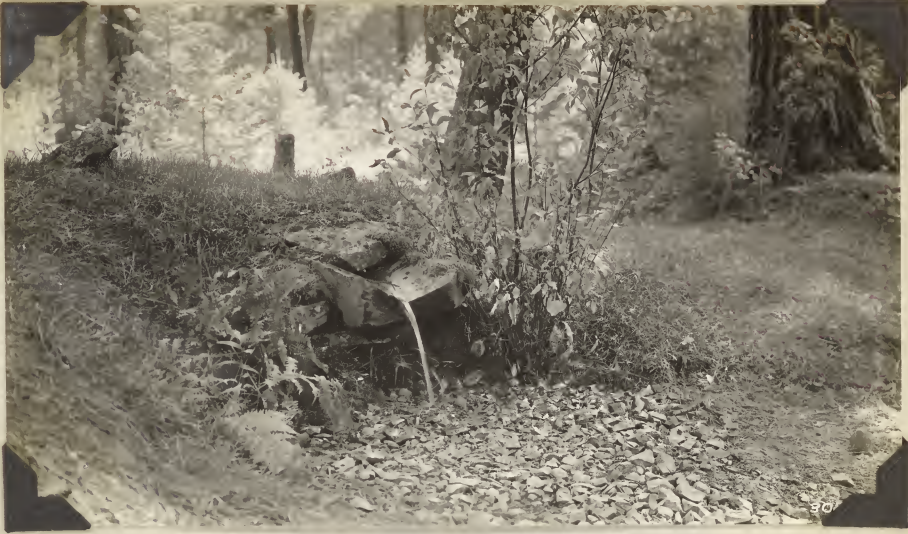
Lolo National Forest - Rock Creek Forest Camp

Detail view of an interesting artificial spring constructed in this camp ground. The design of this spring should be somewhat modified in order to improve the sanitary features. If an artificial feature such as the ones shown in this photograph and No. 308920 (below) is to be built, the most careful consideration should be given to the detail of construction, both in the feature and the immediate surroundings so that the feature may become as nearly as possible a natural part of the setting.

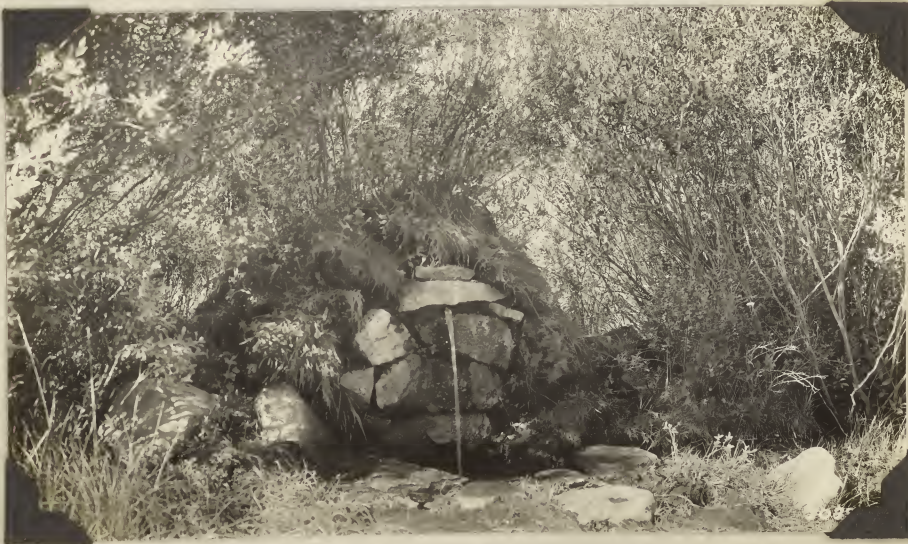
Deerlodge National Forest - Spring Hill Forest Camp

Detail view of the artificial spring effect constructed in this camp ground area.

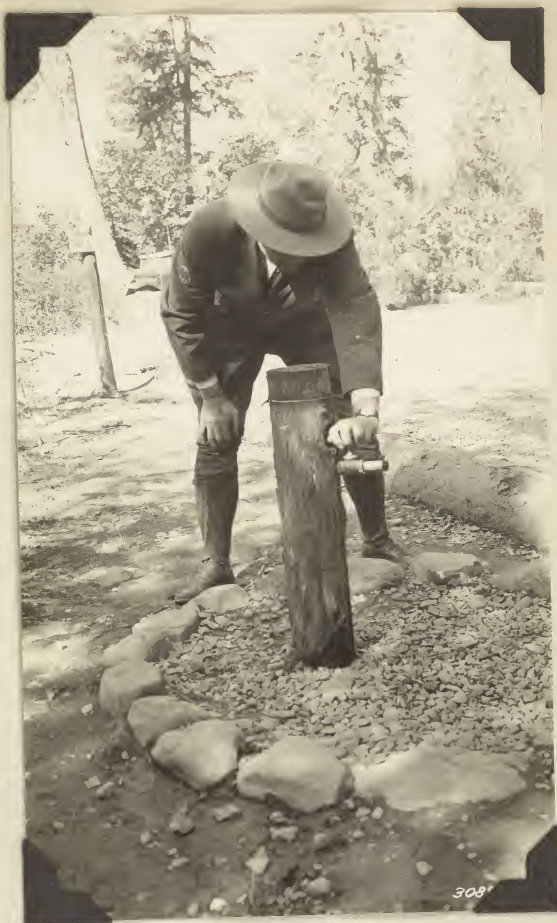
Hydrant in a Tree Trunk

Detail view of a water supply feature where the hydrant has been made to resemble a part of a tree. The faucet, in contrast, is rather crude.

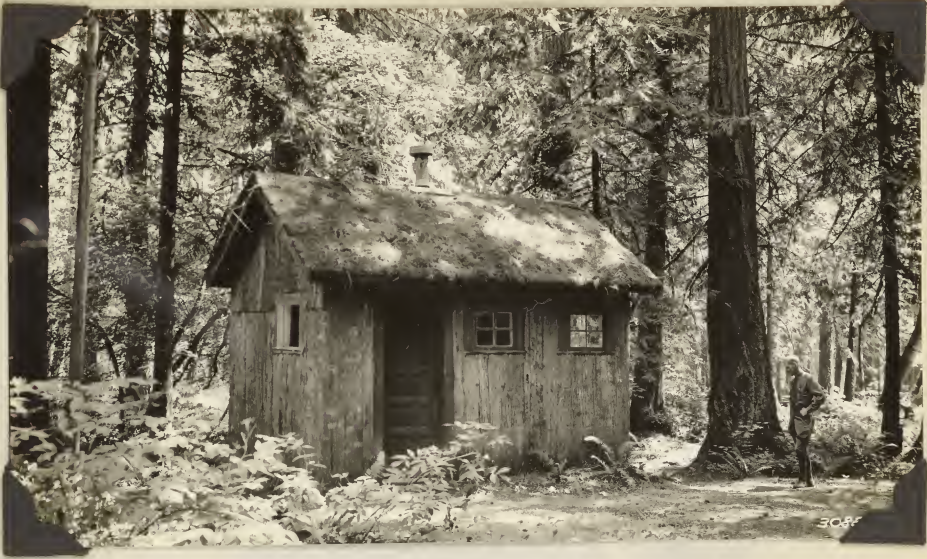
Lewis & Clark State Park, Washington

Detail view of a toilet building, the sides of which are covered with heavy bark and the roof of which is covered with moss. This building produces a very natural effect and, with improvements in the architectural details of doors and windows, could be a most appropriate structure.

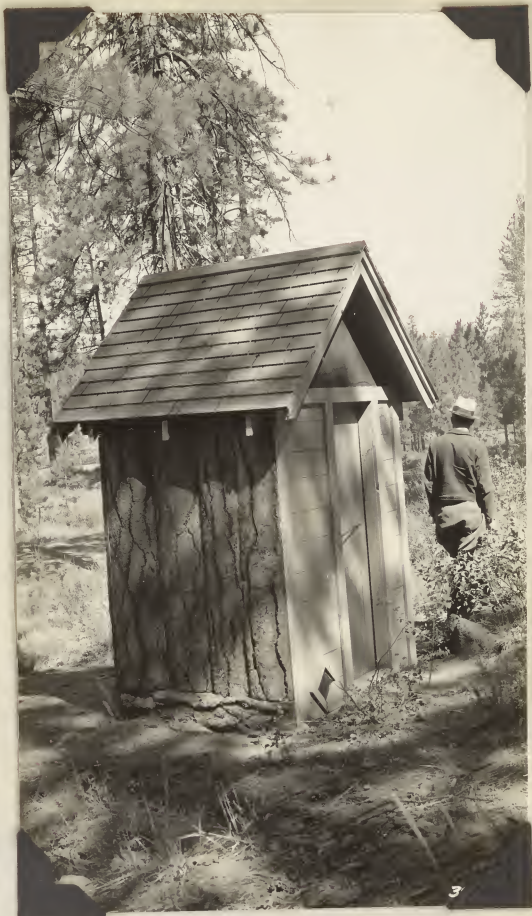
Deschutes National Forest
Metolius River Camp

Detail view of a toilet building, the outside of which has been covered with slabs. Unfortunately, the entrance side of the structure has been left in its original condition. In this instance, there is not an appropriate path approaching the building.

In the Siltcoos Outlet Forest Camp, the toilets are unduly hidden among the heavier undergrowth, while in the Metolius River camp the paths to some of the toilets are not constructed for easy and convenient use.

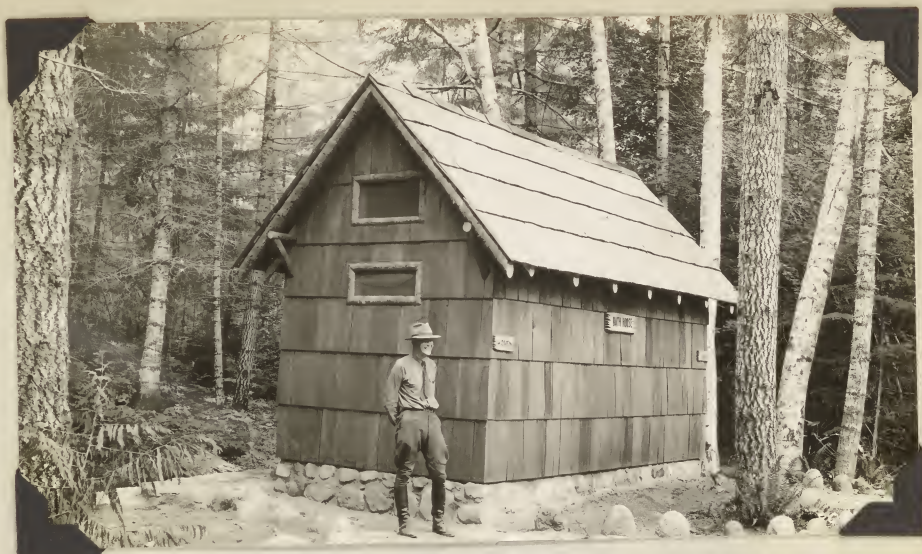
Mount Hood National Forest - Camp Creek Camp Area

View of a very attractively designed small bath house located near the swimming pool. This is a very appropriate building for this location. The sides are of natural wood color to harmonize with the atmosphere among the large fir trees. This design might to excellent advantage be copied in modified form in other Regions.

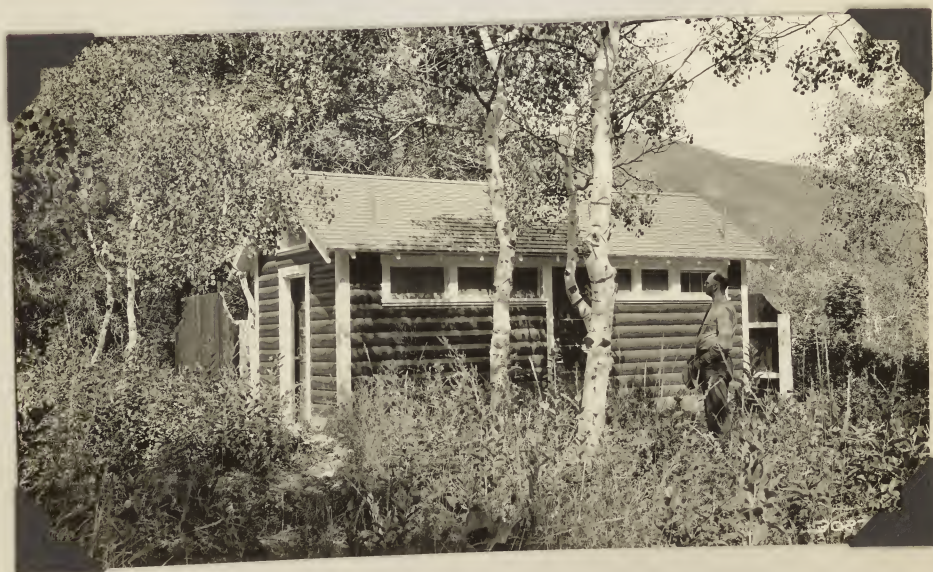
Wasatch National Forest - Aspen Grove Picnic Area

Detail view of a typical larger toilet building now used in Region 4. It seems that the white trim on these buildings makes them somewhat too conspicuous and too "sophisticated" for a forest area.

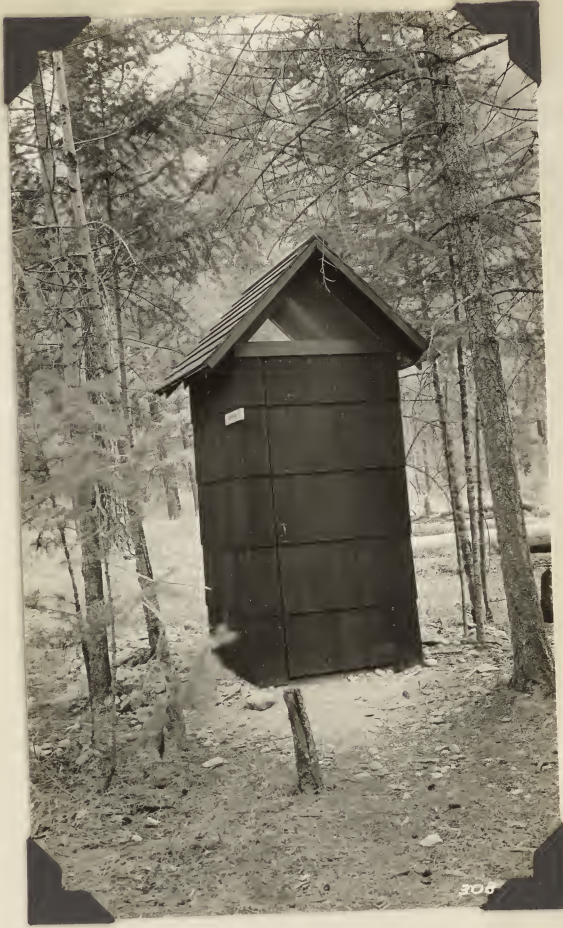
Lolo National Forest
Bitterroot Flats Camp

Detail view of a toilet building in this camp ground. The structure is at least 12 inches too high and the door is unusually high. Such features should not be as conspicuous as this one.

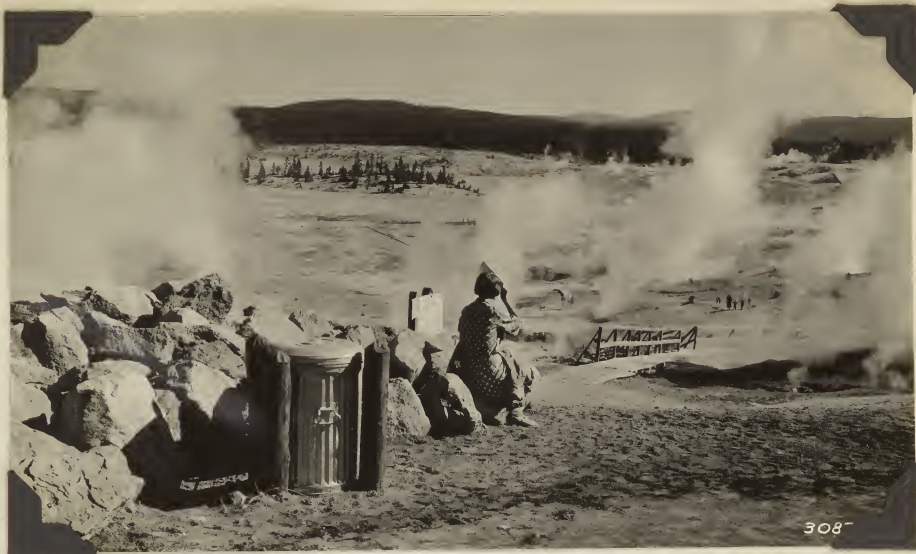
Yellowstone National Park - Norris Geyser Basin

View showing in detail the method of protecting the garbage cans against removal. Note the four cedar or pine posts which are erected in the form of a square immediately around the garbage can.

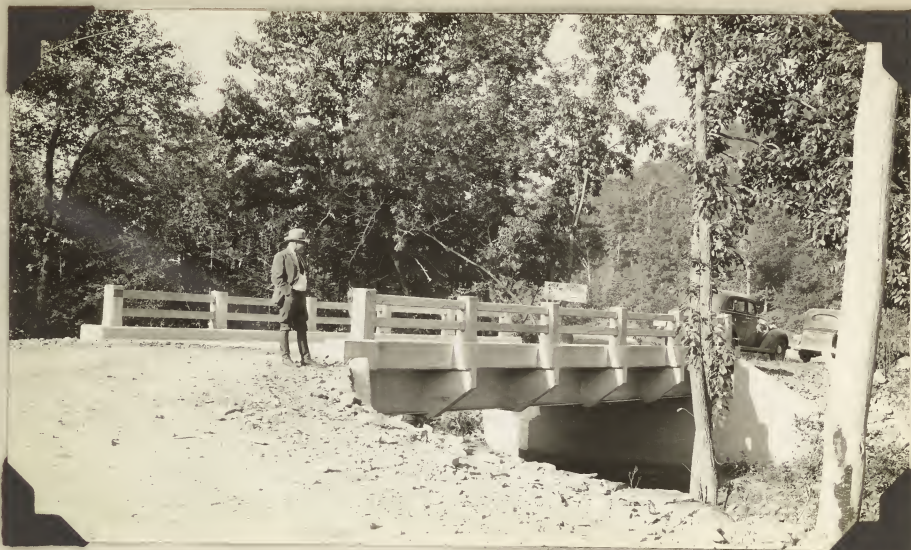
George Washington National Forest - Detail of concrete bridge at intersection of Love-Nash Road and Sherando Lake Road 312173

I recommend, in such locations, that some consideration be given to the advisability of constructing a naturalistic stone masonry bridge which would be more appropriate to the forest surroundings, and especially to the landscape composition of the stream which flows under this bridge. (see photograph No. 2).

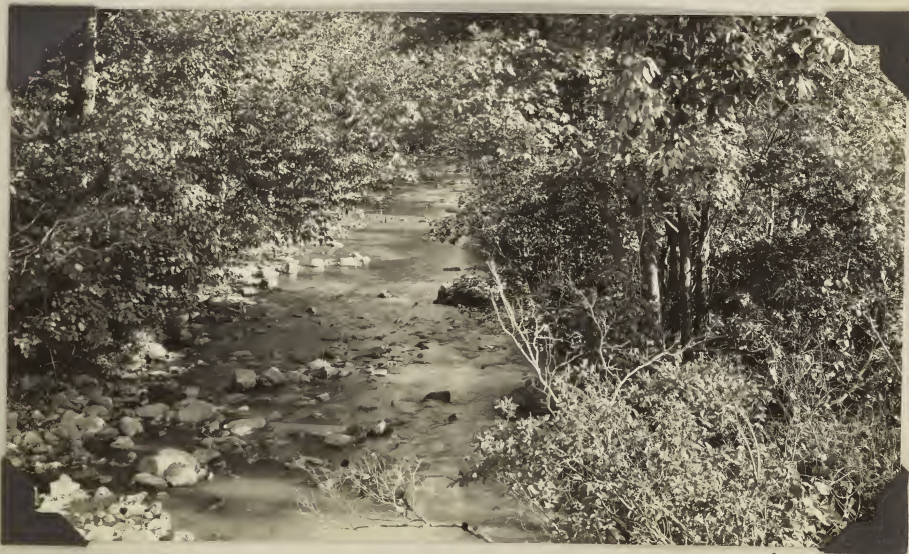
George Washington National Forest - Back Creek 312174

General view looking from Sherando Lake Road Bridge (see photograph No. 1) down the charming creek. Architectural features which are introduced as a part of these fine landscape compositions, should be so designed that they are adapted to the surrounding landscape. (Especially if materials for construction are available and if the cost is not abnormal).

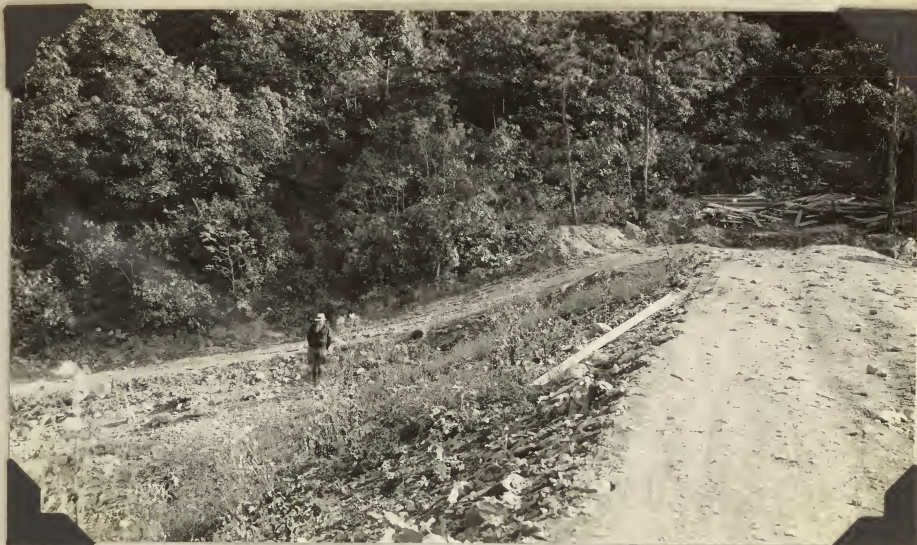
George Washington National Forest - Sherando Lake Earth Dam

Detail view looking toward the abutment on the down stream side of the dam. The additional fill should be almost as high as the shoulders of the man standing in this picture, in order to create a natural transition between the surface of the dam and the existing slope adjacent to it. Sharp contrast between the slopes of the dam and the existing slope should by all means be avoided, especially in a forest setting of this kind.

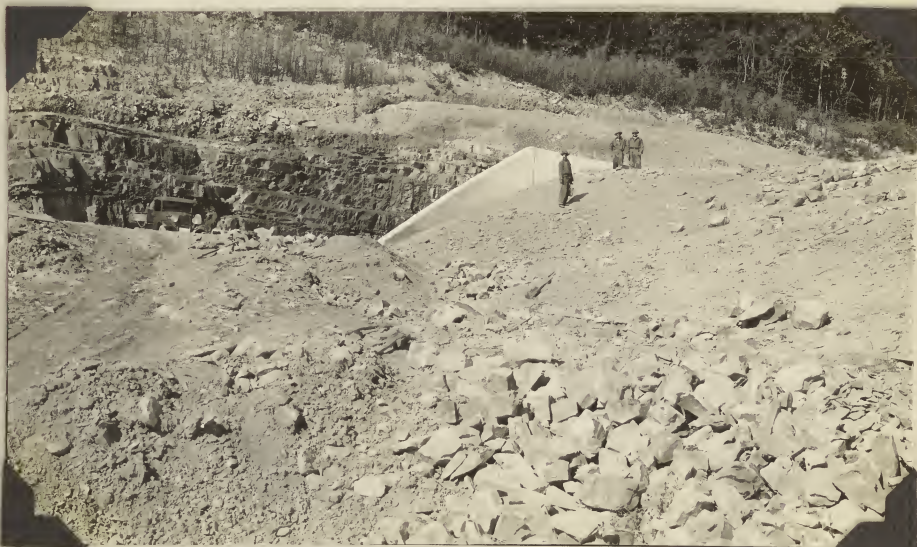
George Washington National Forest - Sherando Lake Earth Dam

Detail view showing the outside face of the concrete retaining wall, which is a part of the spillway. The slope on which the man is standing has been covered with riprap. On abutments of this kind, a special effort should be made to grade the surface of the dam so that the earth will almost completely conceal the concrete wall. An Earth Dam in a forest setting deserves special consideration in order to create an informal and a natural setting.

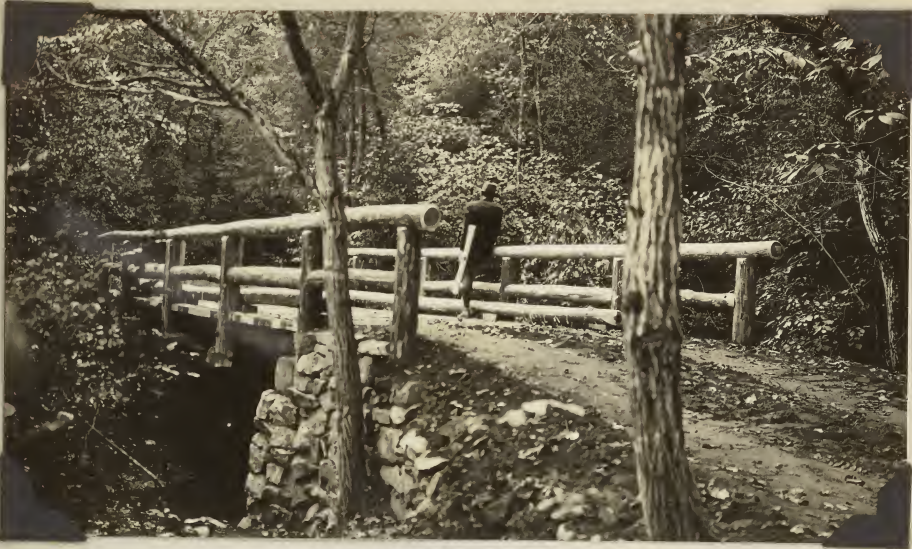
Mountain Lake Purchase Unit - Cave Mountain Forest Camp

This is a part of the proposed Pocahontas National Forest. A most interesting bridge over the stream to provide access for foot traffic and for service automobiles, from the parking space to the bath house. This type of bridge is very appropriate to the forest surrounding and is well designed.

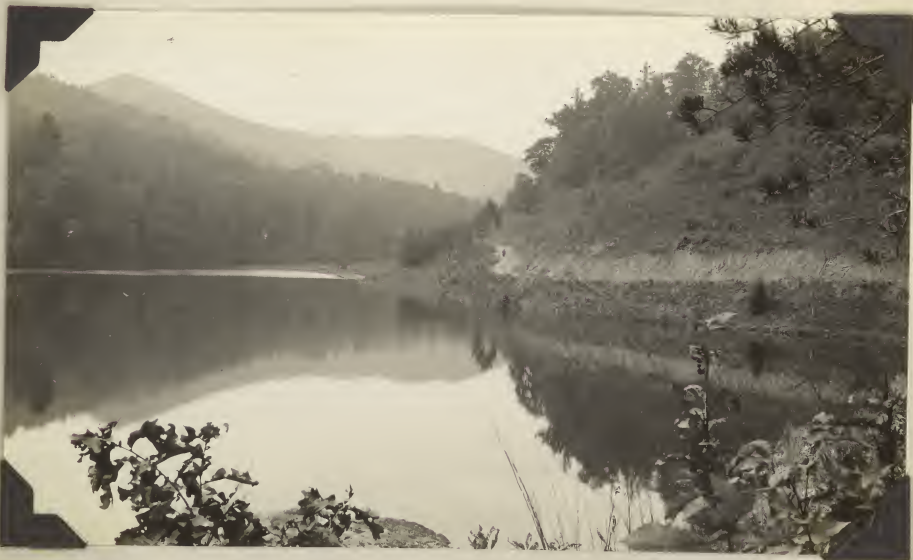
Mountain Lake Purchase Unit - Lake at Cave Mountain Forest Camp

This naturalistic lake is exceptionally well planned and with the completion of the proposed naturalistic planting on the bank between the forest road and the shore of the lake, the setting will be ideal for recreation activities in which opportunities for bathing are an important factor.

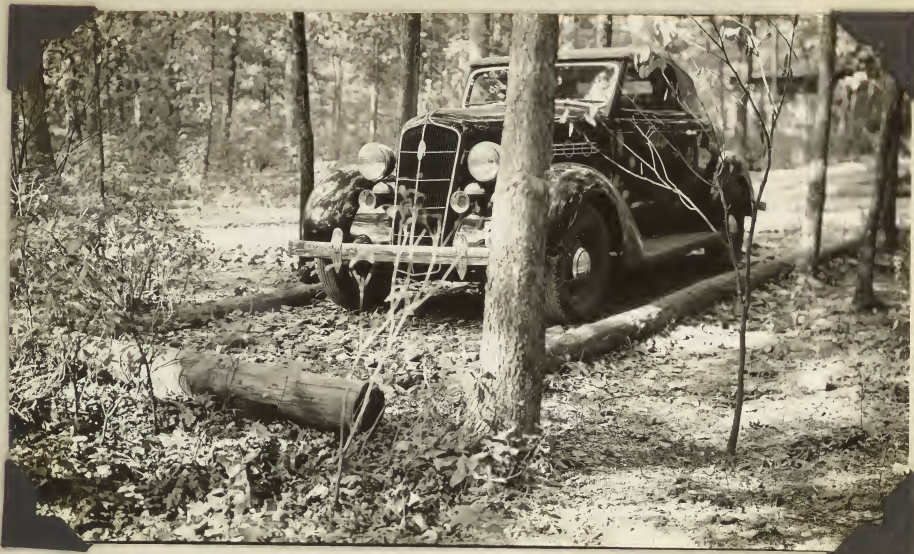
Douthat State Park - Special Use Areas

Detail view showing the use of logs to define the parking "spurs". These logs used in this way in this location are very practical and fully meet the requirements.

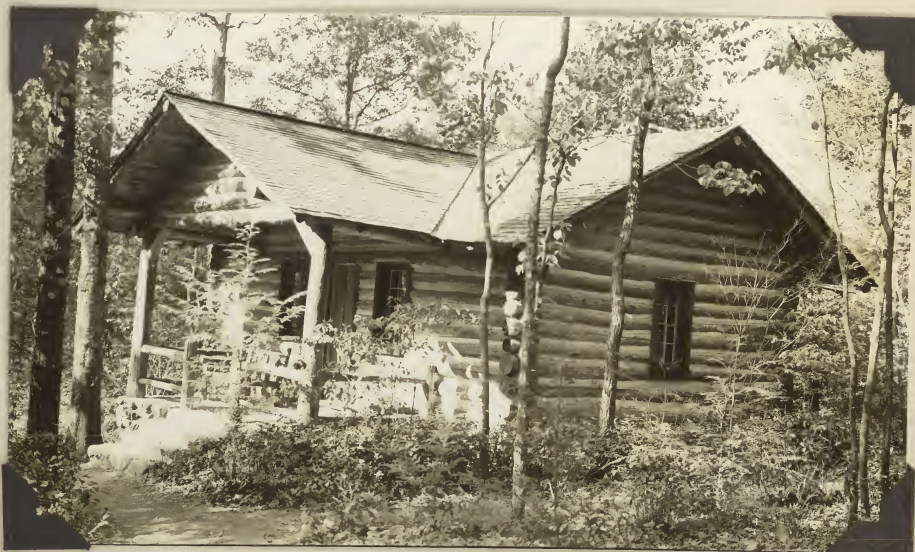
Douthat State Park - Special Use Areas

General view showing a most interesting type of cabin or camp which is being constructed for rental by the park authorities. The construction of these cabins requires approximately \$200.00 for fixtures, plumbing, hardware, etc., and approximately six hundred labor hours. The proposed rental is at the rate of \$7.00 per week.

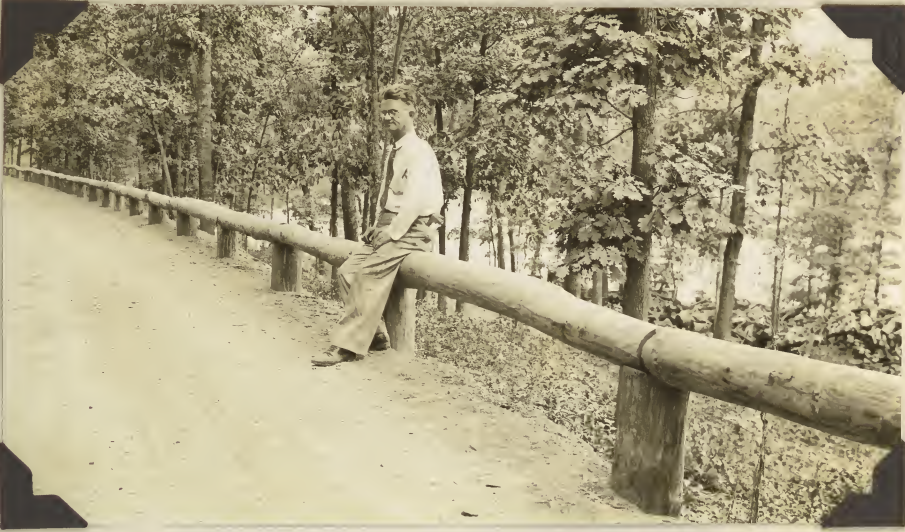
Douthat State Park, Va. - Roadway through Park

Detail view of the guard rail which is used in this picnic area. The top of the guard rail ought not to be more than 18" in height. This guard rail is at least 24".

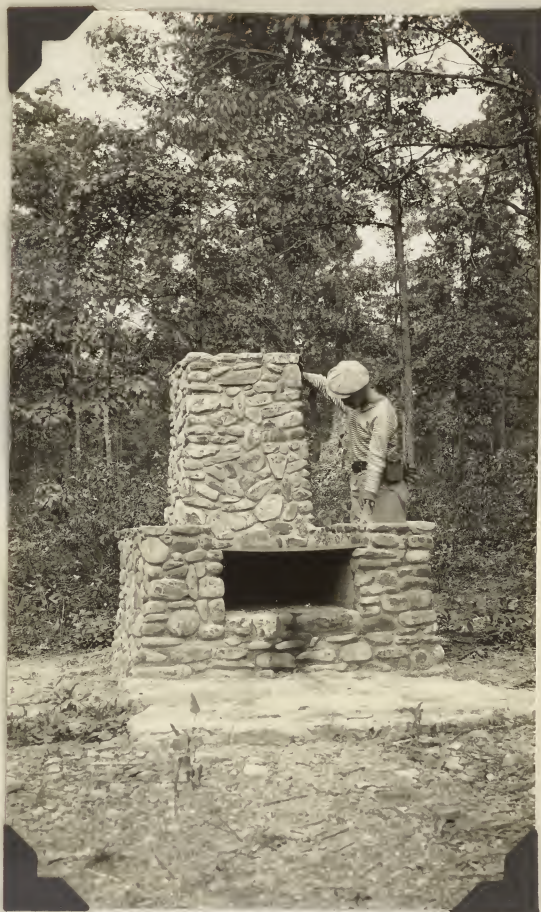
Douthat State Park, Va.- Picnic Stoves

The stonework in this feature is too fine in texture and not well laid. The chimney should be provided with a damper. Without some additional provision, the plate over the fire box will warp as is evidenced in this photograph.

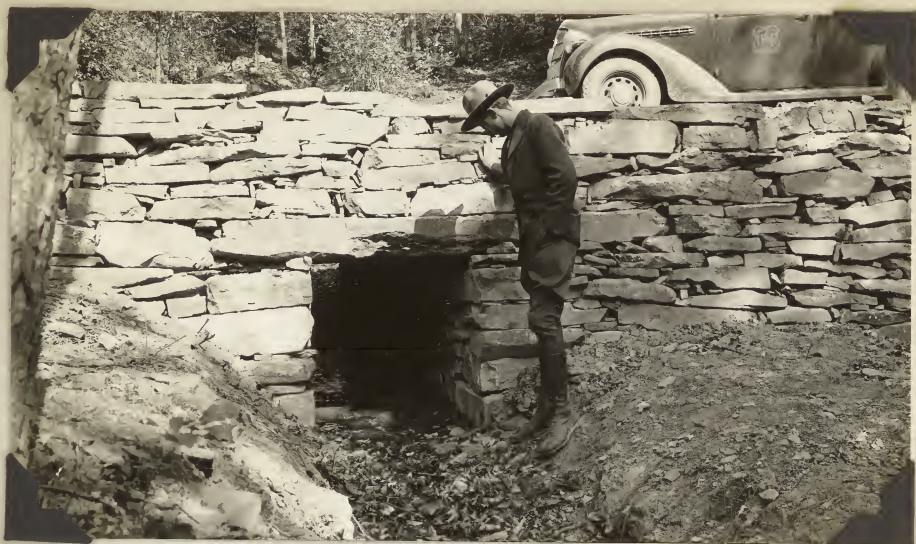
Monongahela National Forest
Retaining wall and culvert on Franklin-Warm Springs Turnpike

An excellent type of culvert. The texture of the stonework in this dry stone retaining wall could be improved by a more careful selection of the larger stone, and by omitting the "chinkers". Refer to photograph No. 21 for the type of stonework which presents a more attractive texture.

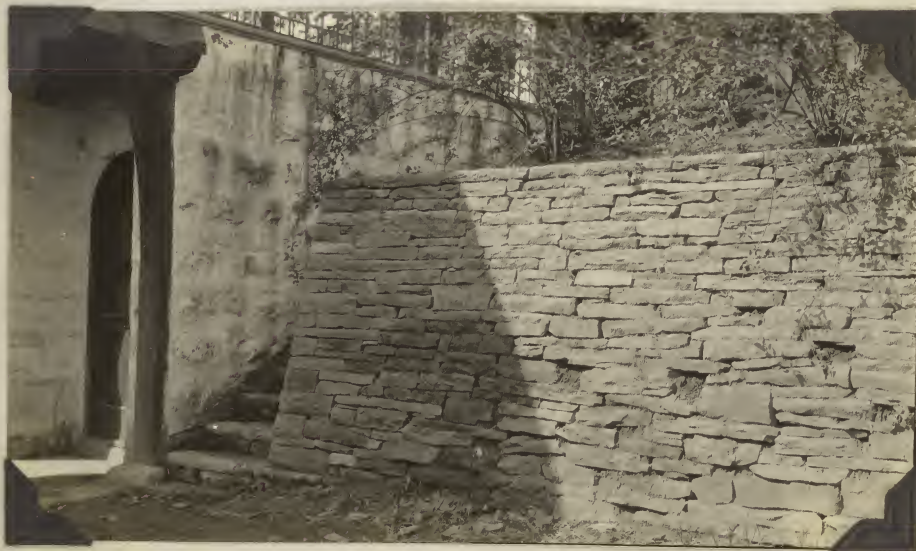
Detail photograph of a dry stone retaining wall, showing the effect which is produced where very few, if any, "chinkers" are used. The effect of the wall is much more stable and uniform.

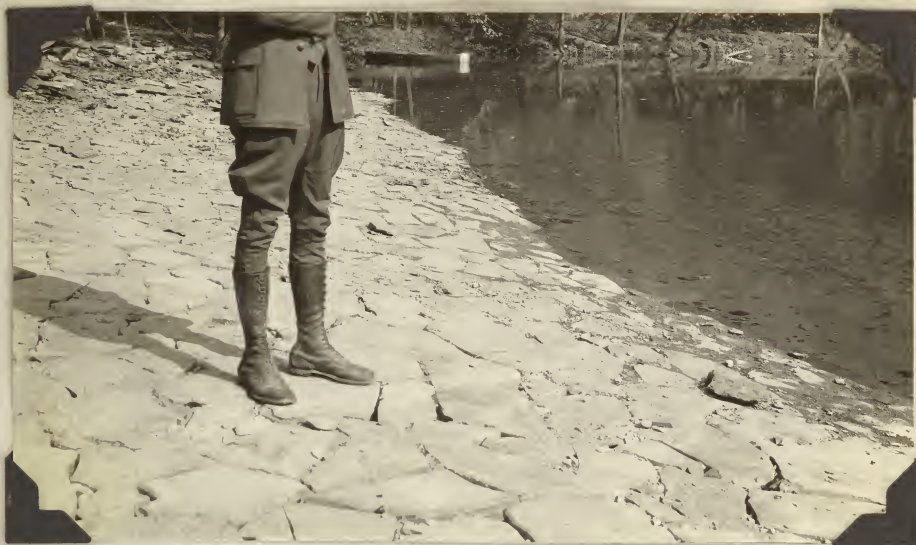
Monongahela National Forest - Blue Bend Camp Ground

Detail photograph showing the method of paving the shore of this water area in order to provide a "beach". In this instance, this feature is well planned.

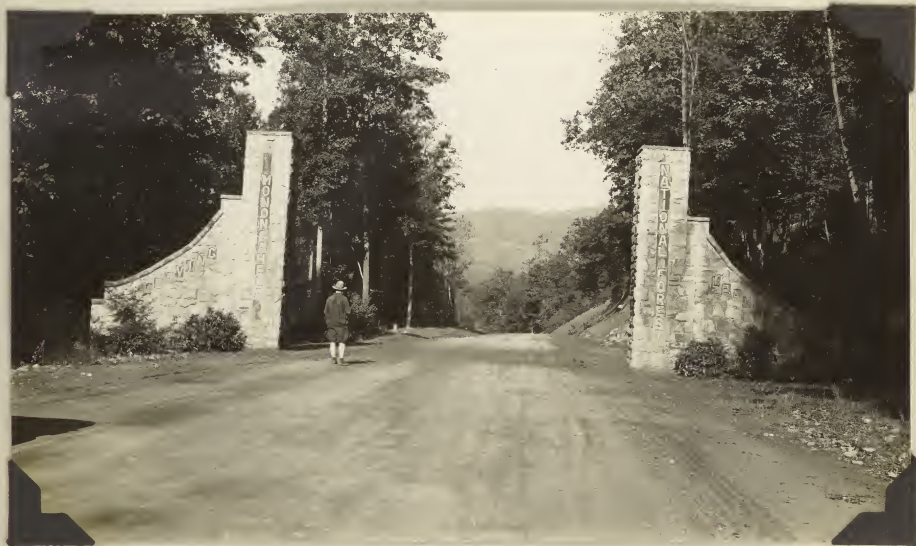
Monongahela National Forest - Forest Entrance on Shavers Fork Rd.

General view of a very definite forest entrance which in this location is a very appropriate feature, especially after some additional grading and some further planting has been completed. Entrances of this kind require considerable native plant materials to frame properly the entrance feature.

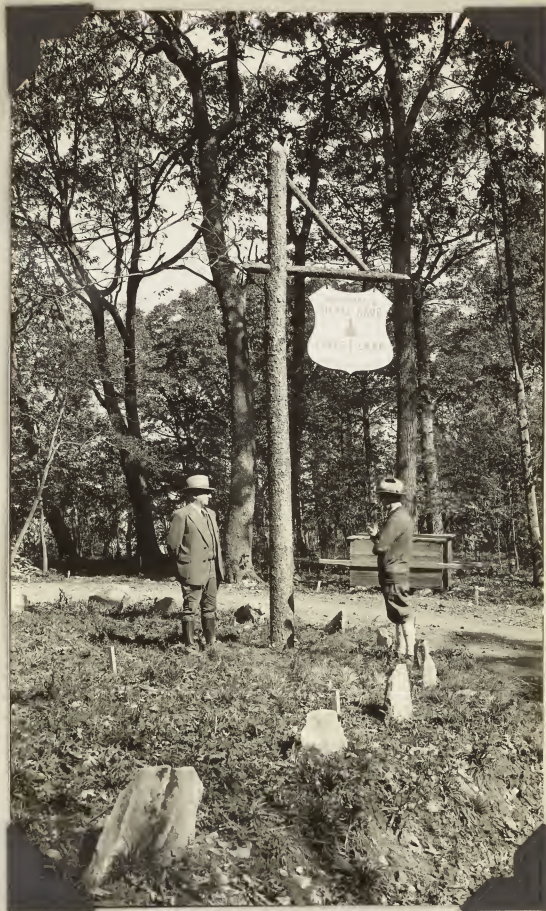
Monongahela National Forest
Bickle Knob Forest Camp

Detail view of a sign marking this camp area. This sign does not seem to be appropriate for a small camp area. It is too pretentious and too high. The contrast between the post covered with bark and the white painted sign is too great. A sign of natural wood color, with black letters, would seem to be more appropriate.

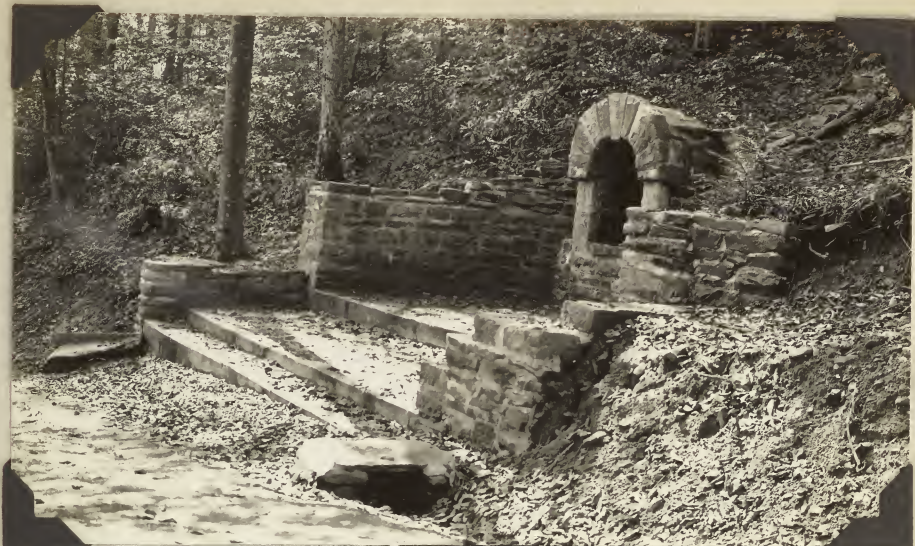
Monongahela National Forest - Spring at Side of Road

Monumental features of this kind should be avoided. It is not well designed. The entire front portion, including the first step and the platform immediately in front of the upper platform should be entirely removed. The arch over the spring feature should be redesigned and reconstructed and the spring should be framed with a natural planting of rhododendrons and other native materials. This feature is very inappropriate as now designed and located.

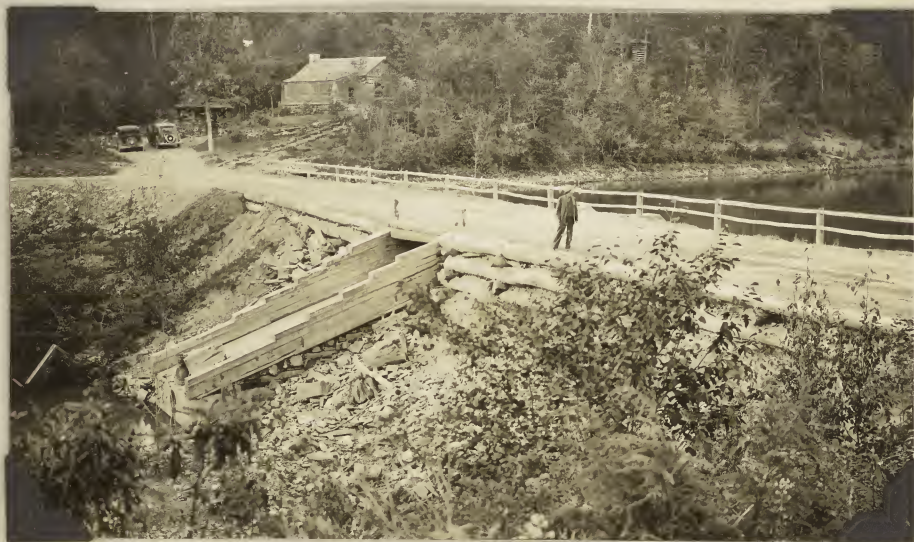
Seneca State Park - Earth Dam

Detail view of wooden spillway. The dam already leaks and will continue to become worse. The spillway is not only an unsightly feature, but it is extremely poor design and construction. Undoubtedly it will be found advisable to reconstruct the entire dam within the next three or four years. Such a waste of public funds is not justified. More careful planning would have produced a very attractive Earth Dam in this location without any additional expense.

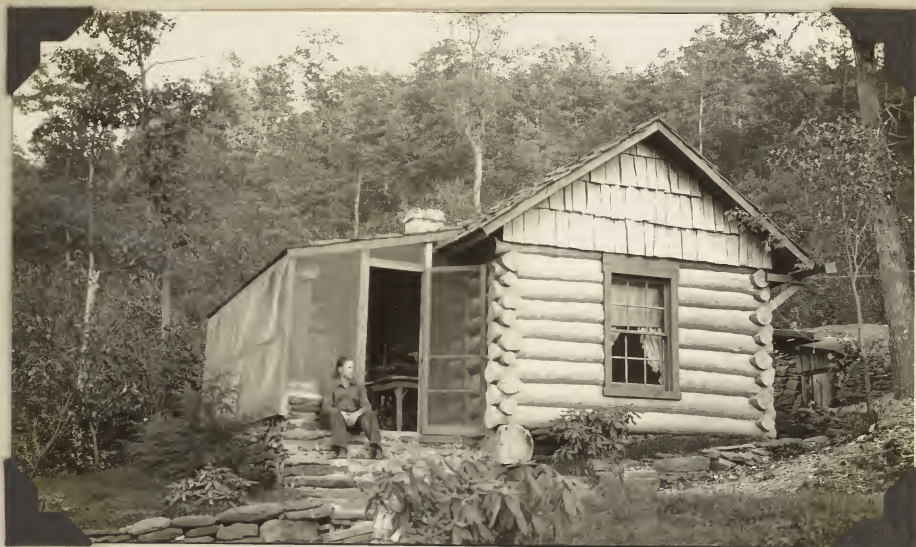
Seneca State Park - Special Use Camps

Detail view of one of the small cabins which is constructed for rent in this park area.

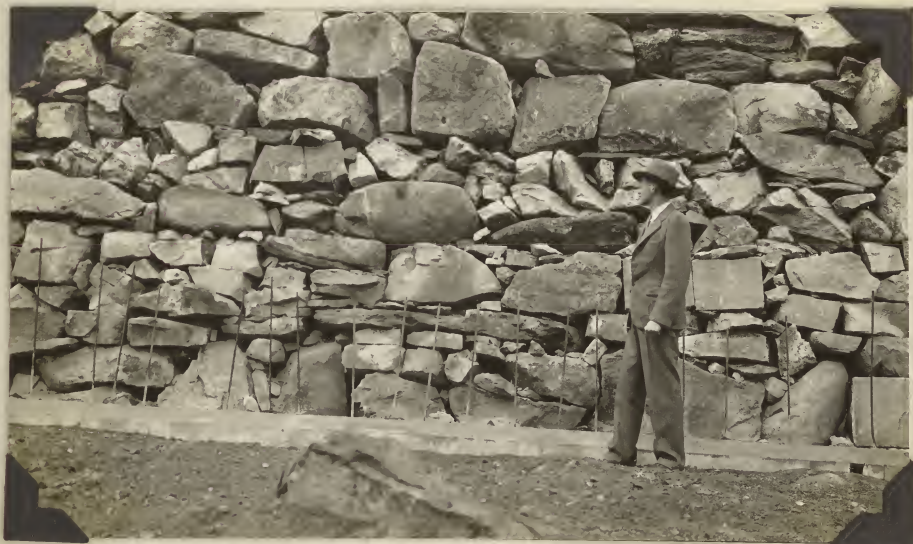
White Mountain National Forest - Campton Dam

Detail of a dry stone retaining wall. The texture of this wall is not good. The reason for this condition is due to the fact that the original intention was to veneer the face of this wall with concrete. The proposed concrete construction does not seem necessary in order to create the necessary stability. A proper stone texture would be much more desirable than a plain concrete surface.

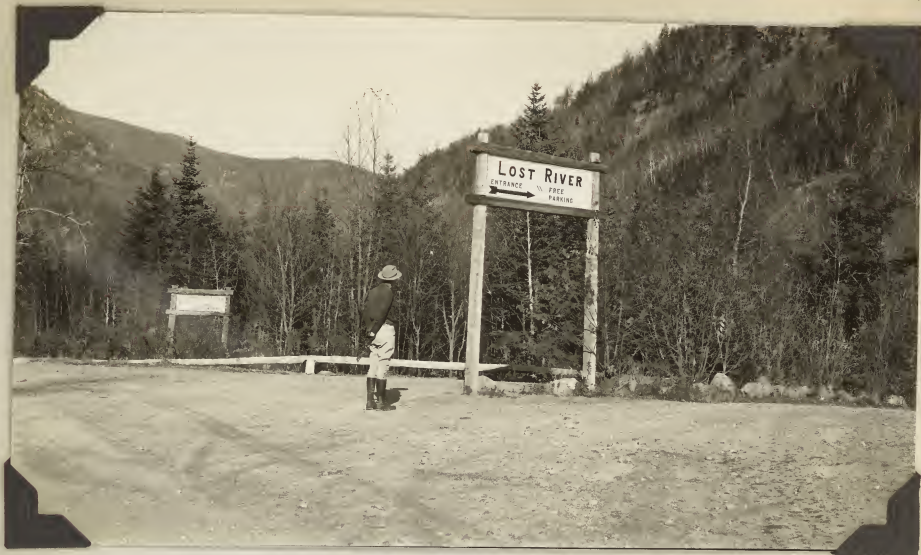
White Mountain National Forest - Lost River Camp

General view of entrance sign. This type of sign could be greatly improved if the background of the sign were a natural wood color.

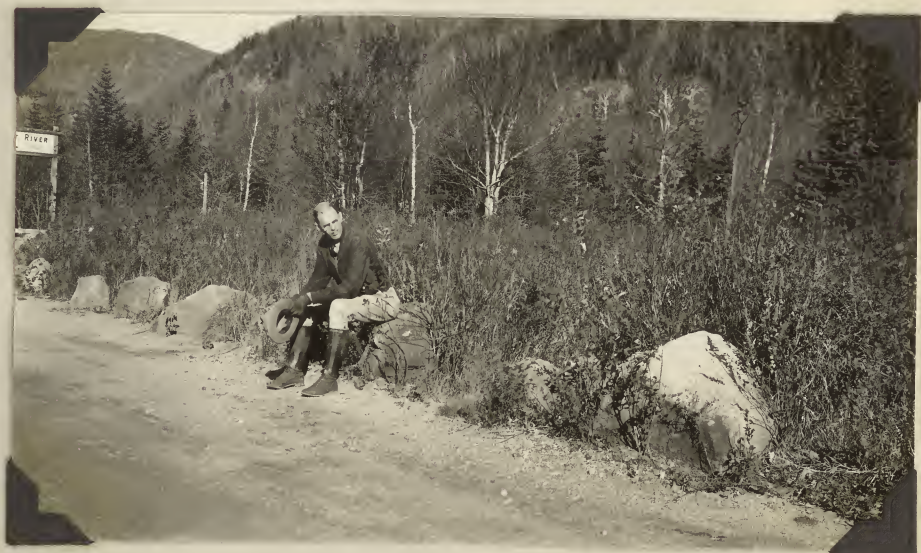
White Mountain National Forest - Lost River Camp

Detail view showing a very interesting and informal arrangement of boulders forming a barrier along the edge of the drive. Note the vines and shrubs which partially conceal these stones during the summer season.

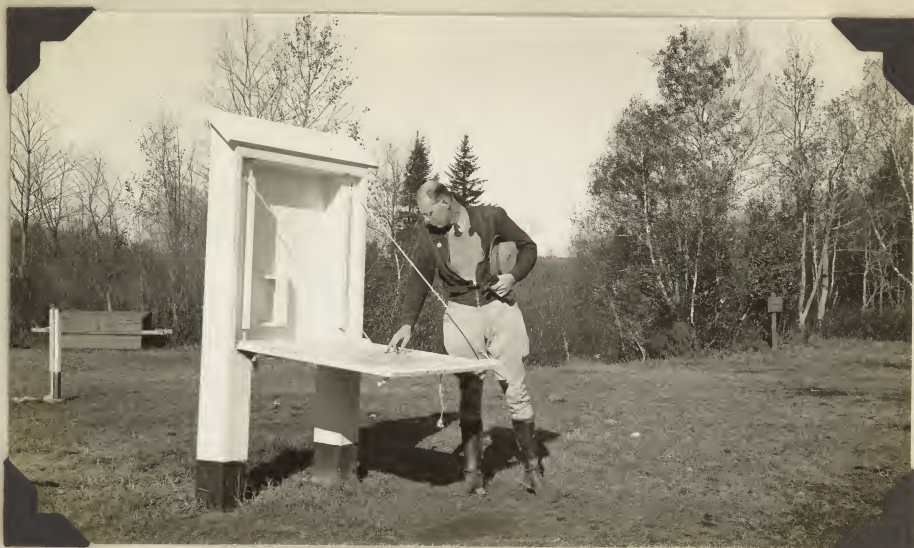
White Mountain National Forest - Wildwood Forest Camp

Detail view of the registering booth. It seems to me that a natural wood color might make these registering booths less conspicuous. If the registering booth is to be painted white, there should be less of the creosote or black portion showing above the ground.

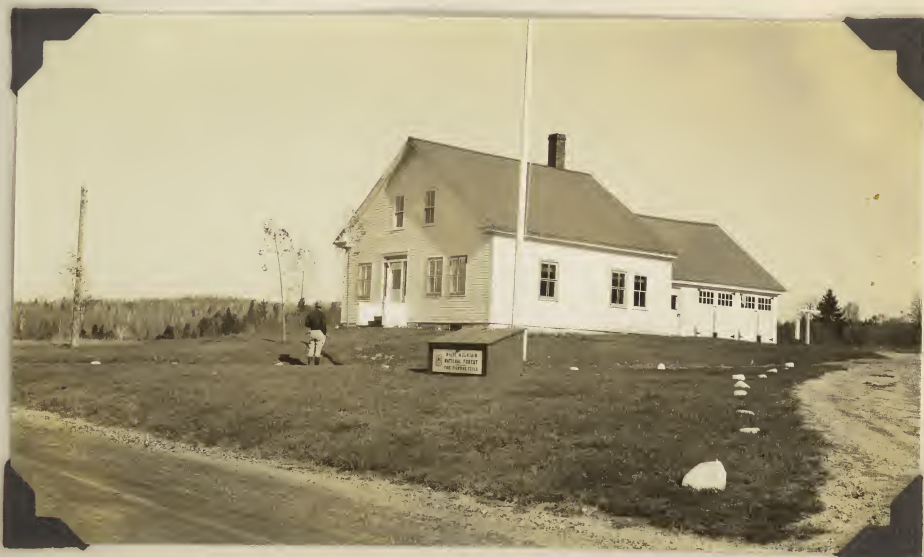
White Mountain National Forest - Wildwood Ranger Station
(On Route #212)

This ranger station should be given an attractive and natural setting by the planting of trees, and especially of native shrubs in proper locations around the foundation of the building.

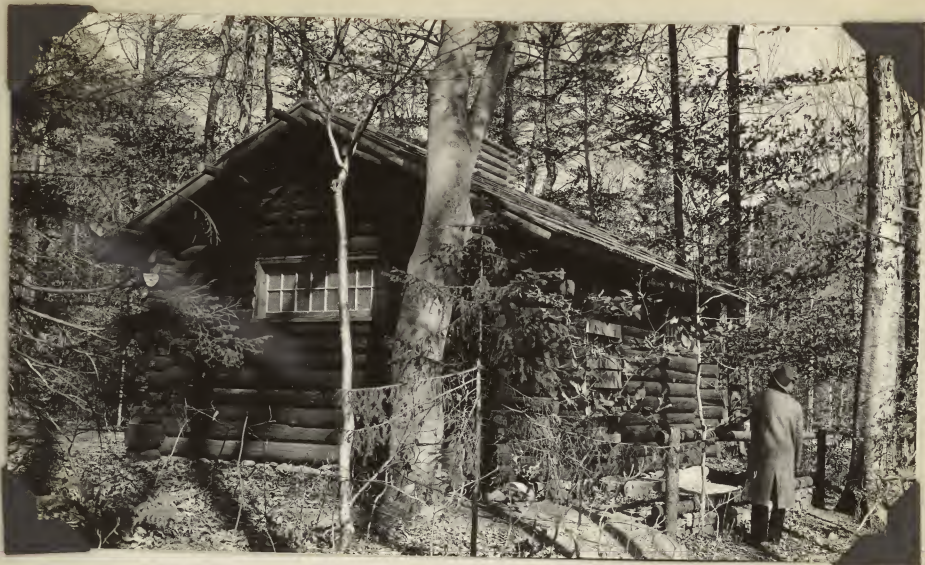
White Mountain National Forest - Franconia Notch Reservation
(Lafayette Opening)

Detail view of large toilet building of a most attractive design and placed in a very natural setting.

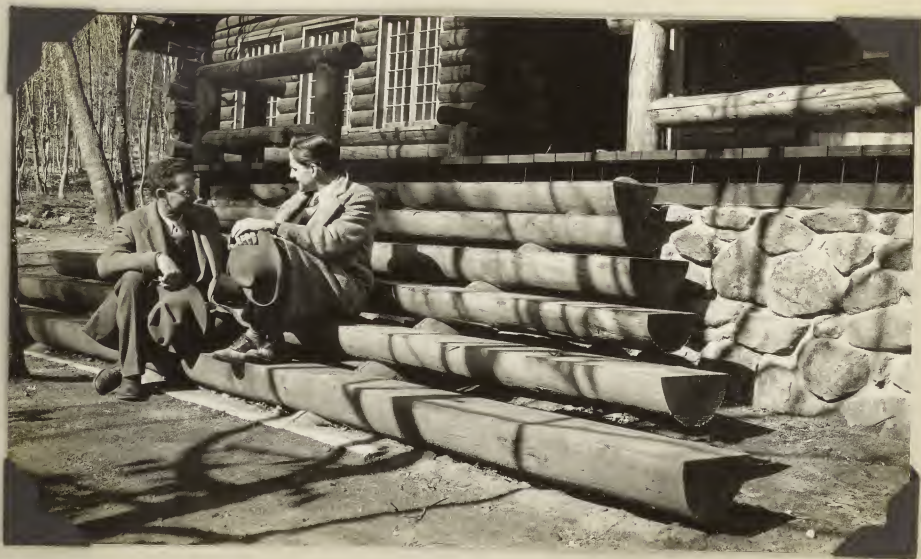
White Mountain National Forest - Franconia Notch Reservation
(Lafayette Opening)

Detail view showing unusual construction of main entrance steps in front of recreation building.

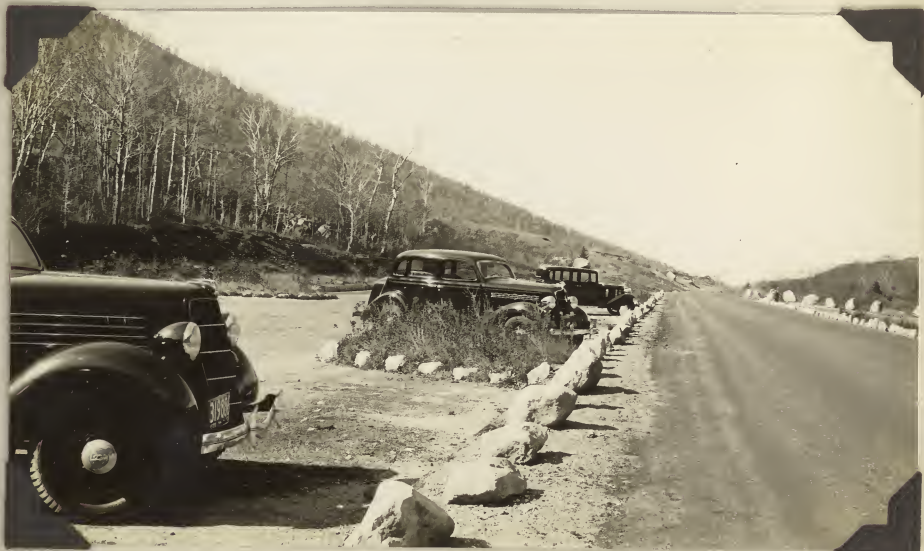
White Mountain National Forest - Franconia Notch Reservation

General view showing an unfortunate relationship of large parking area to the main highway. This parking area should have been screened from the main highway by a strip of native planting. As now developed, it is an unattractive and distracting element on an otherwise beautiful highway. The arrangement of stones, as barriers, is also not pleasing.

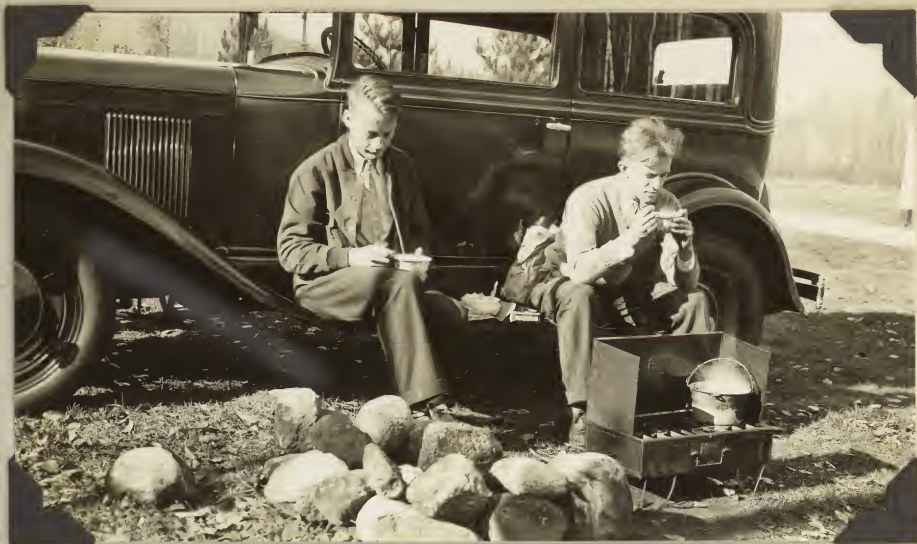
White Mountain National Forest - Gale River Forest Camp

Detail view of a camp fire showing the way in which the majority of campers prepare their food upon a small portable gas-line stove rather than over the camp fire.

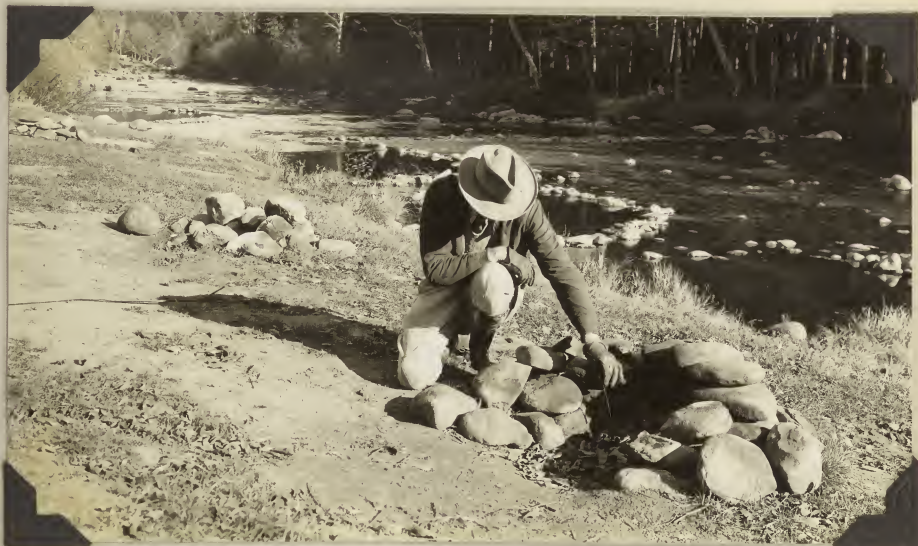
White Mountain National Forest - Zealand Forest Camp

Detail of typical informal fireplace, constructed by the campers, and generally used in the White Mountain area. Such an open fireplace could not be used safely in the timber.
